# An evaluation of the use of the Surtronic S128 to assess appropriate cleaning techniques for historic materials.

By Naomi Watts-Kitto and Jocelyn Cook

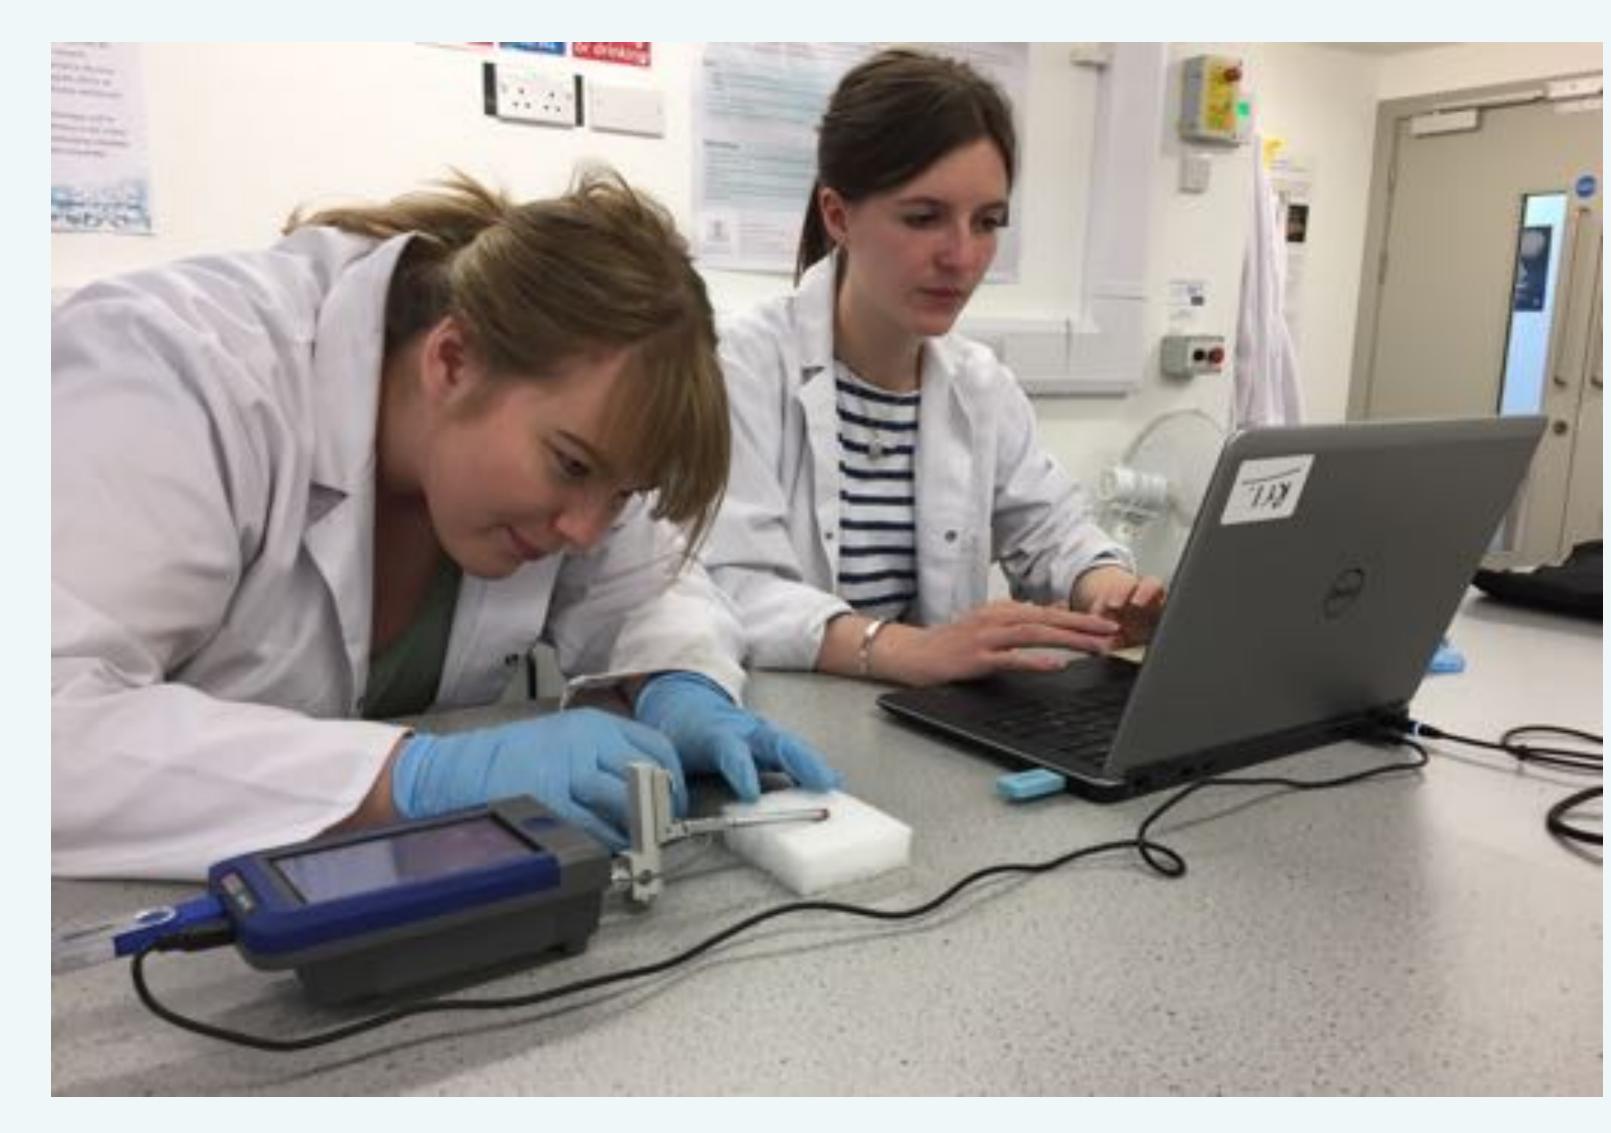
Fig.1: The authors N. Watts-Kitto (left) and J. Cook (right) using the Surtronic S128. © 2018 Naomi Watts-Kitto. All rights reserved.

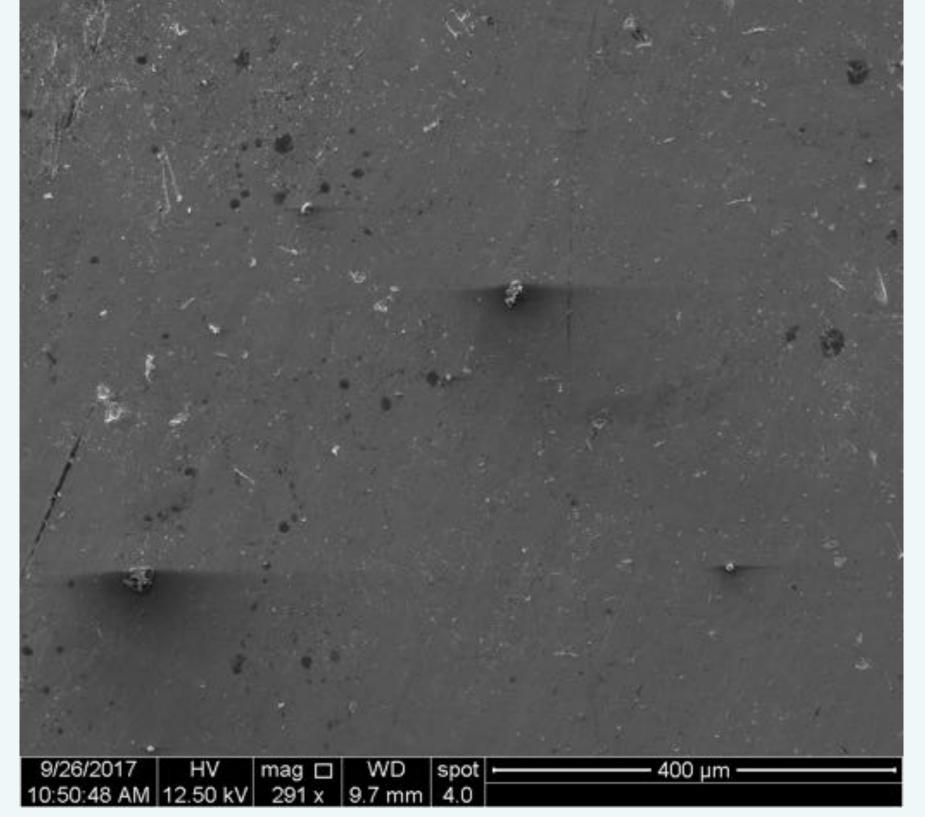
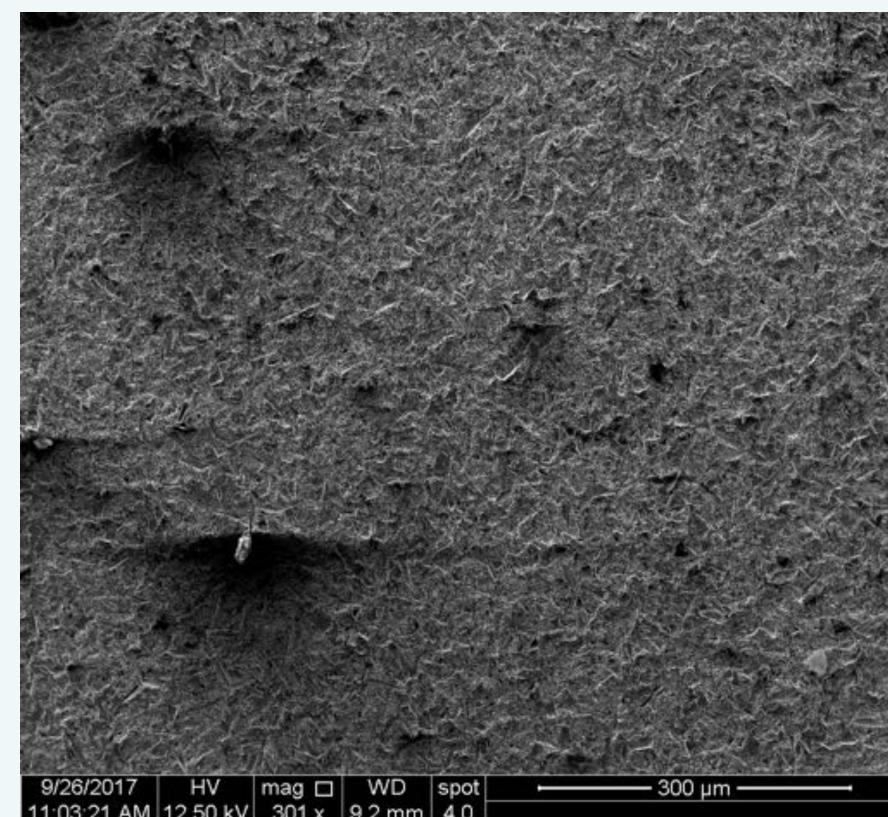
Fig. 2: SEM images showing the surface of a copper sample before and after air abrasive cleaning (respectively). © 2018 Naomi Watts-Kitto. All rights reserved.

Scanning Electron Microscopy (SEM) was also used to corroborate these results.

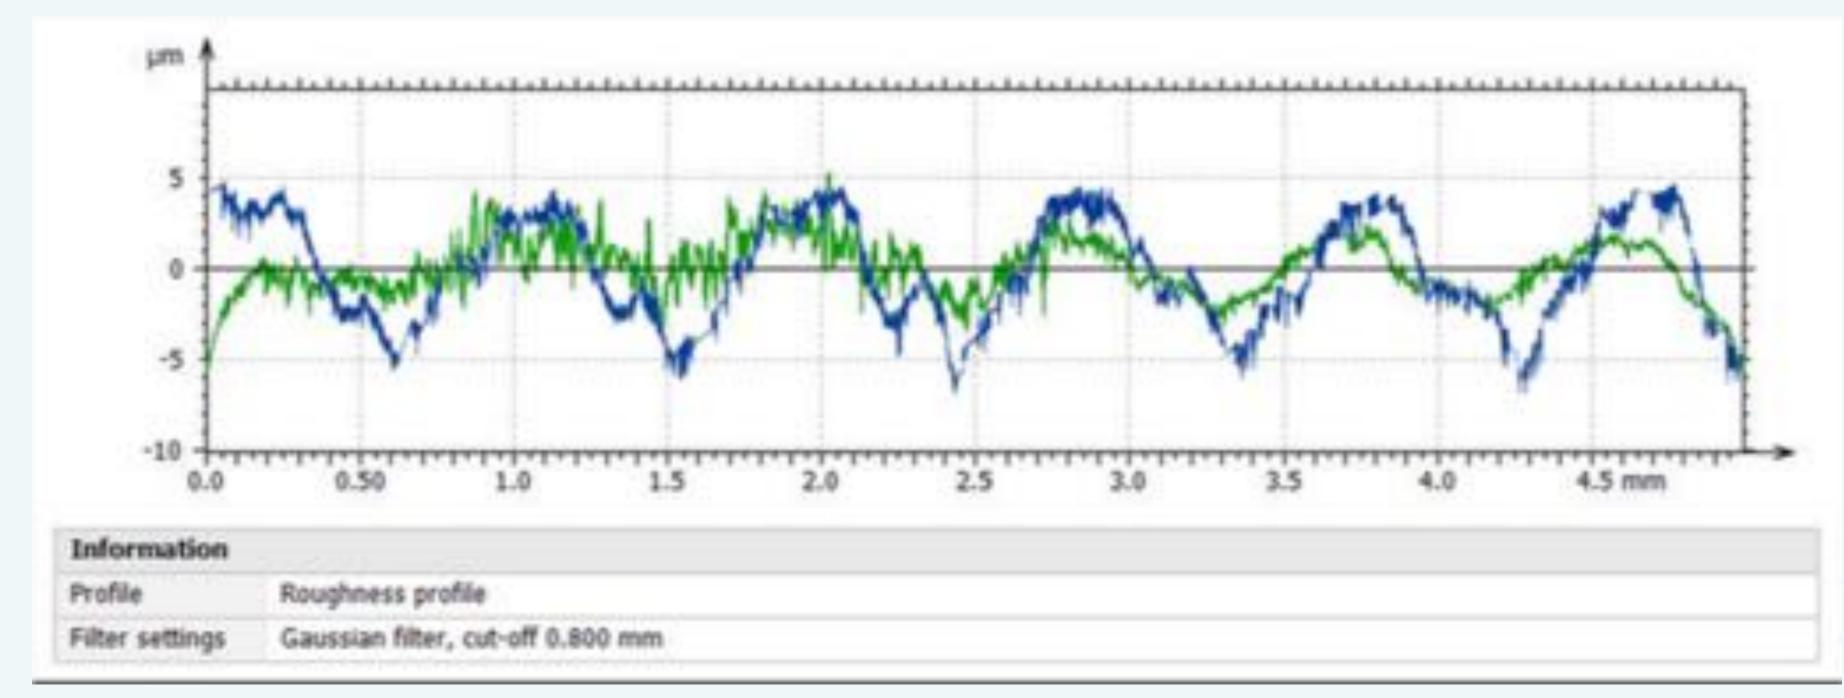
Fig. 3: A roughness profile for a copper sample cleaned with the air abrasive.

Blue = Before cleaning.

Green = After cleaning.

Although the cleaning methods described above are commonly used by conservators, the surface roughness profiles show material loss or redistribution as a result of cleaning across all the samples, regardless of the cleaning techniques used. The sensitivity of the Surtronic S128 allows for comprehensive topographical sample analysis and offers conservators an affordable and portable analytical instruments for undertaking quantifiable analysis.
